**Impact of climate change on wood deterioration -
Challenges and solutions for cultural heritage
and modern structures**

Paper prepared for the 41st Annual Meeting
**Joint session IRG WP 1.8 “Cultural artefact protection” and
COST Action IE0601 “Wood Science for Conservation of Cultural Heritage”**
Biarritz, France
9-13 May 2010

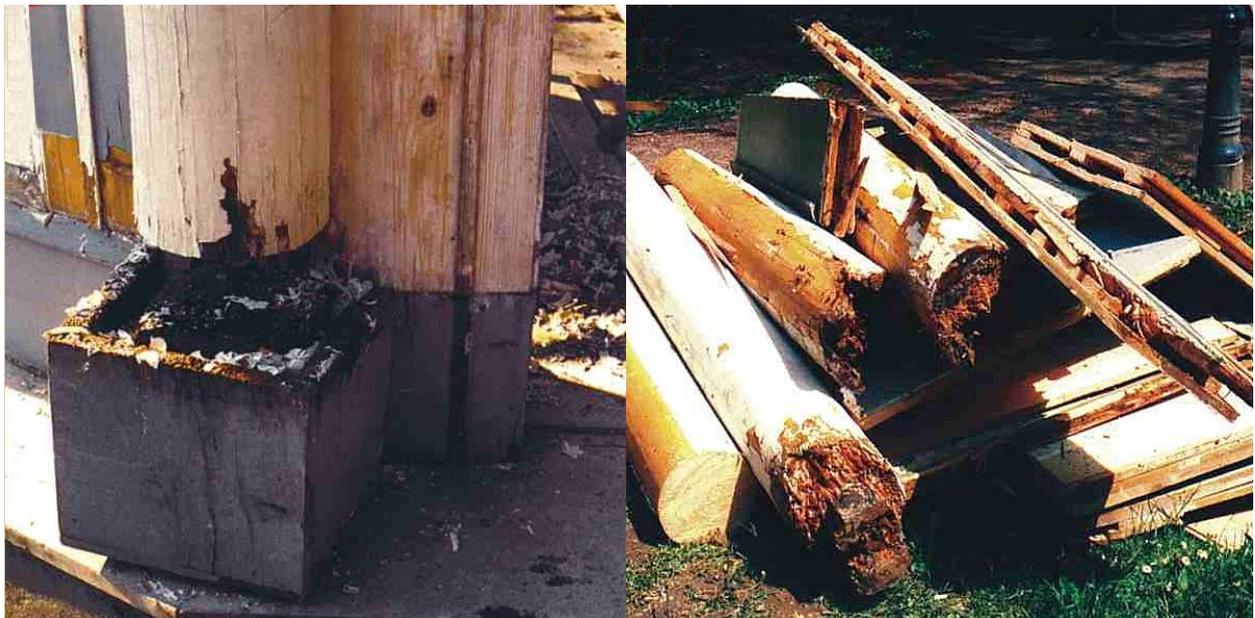
Figure 5: Decayed poles (brown rot, mainly *Gleophyllum abietinum*) and soft rot found and replaced during the restoration in 2001.

The solution for the poles and the lower parts of the pavilion was chemical preservation using tebuconazole based products. All decayed wooden parts were checked and repaired. Instead of earlier used and now decayed silver fir (*Abies alba* Mill.) and spruce poles, larch (*Larix decidua* L.) and spruce heartwood were chosen for producing new poles. Each pole was built of beams glued with resorcin formaldehyde glue, and then turned. The bases and Toscan's bases were made of Slavonian oak heartwood (*Quercus pendunculata* L.) and protected with water repellent paste. Boron wood pills were put in the bottom of each panel and pole. All wooden parts were preserved by three minute immersions, or by spraying and brushing with tebuconazole solved in white spirit. After preservation and assembling, the poles and panels were coated with a three-coat alkyd based primer-undercoat-mat system for boats.

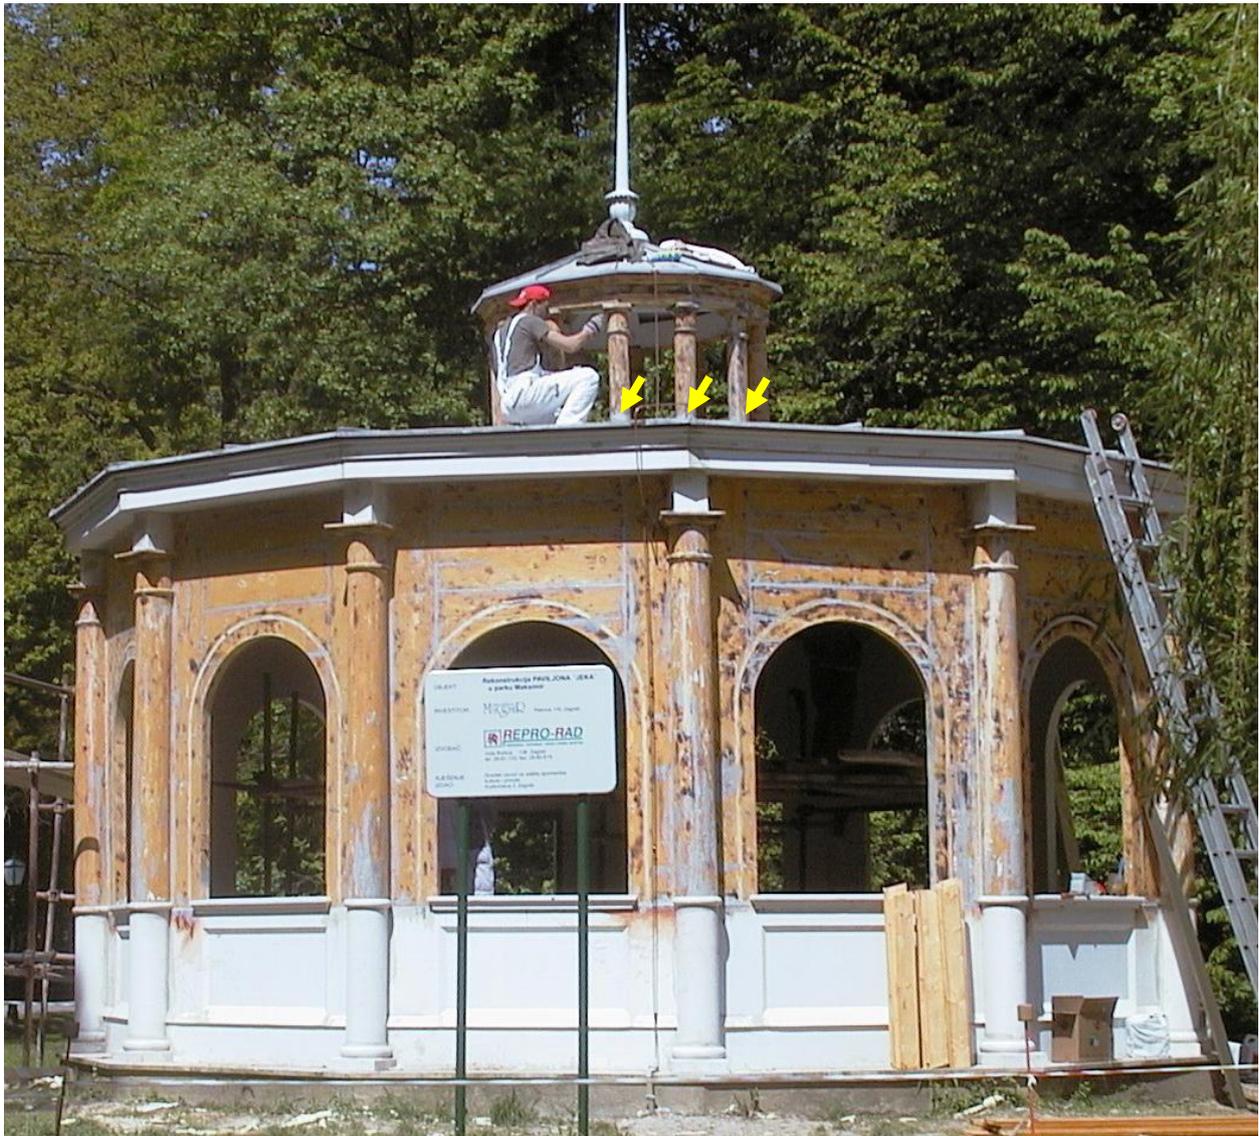
Figure 6: Restoration work in 2001. Yellow arrows: critical connection between the little top pillars and the roof sheeting.

The solution for the roof construction was a silicone based permanently elastic sealant to prevent water running into the roof where the little top pillars (marked with yellow arrows in Figure 6) on top of the roof are connected to the roof sheeting.

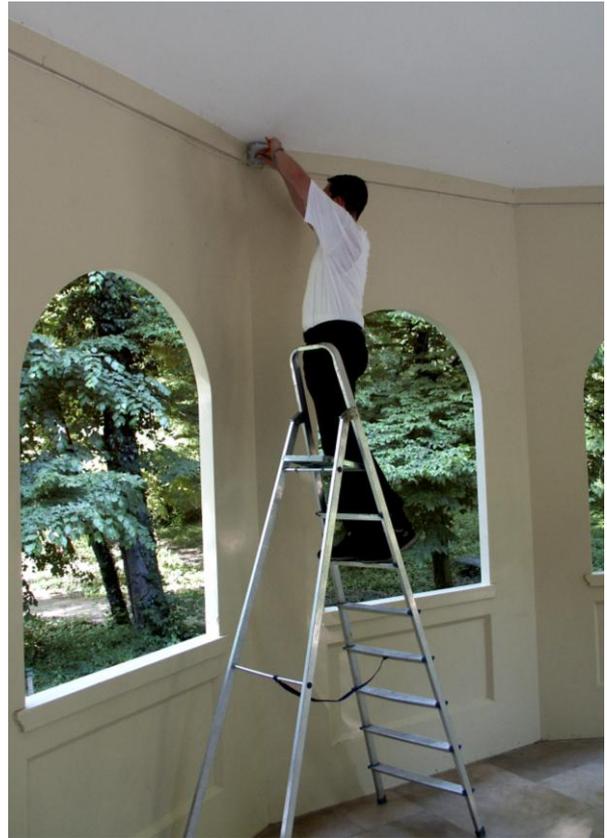
Figure 7: Installation of moisture monitoring device. Left: Position of the three measurement points in the roof. Right: Installation of data logger box.

However since “permanently” elastic sealants are in reality never permanently elastic, but only for a limited duration, a wood moisture monitoring system was installed at different positions inside the roof (Figure 7). Stainless steel screws drilled into the spruce roof beams in a distance of 30 mm to each other served as electrodes for the MC measurement based on electrical resistance. Cables were attached to the electrodes and run to a little box in which the data logger (Materialfox mini, Scanntronik Mugrauer, Zorneding) was stored.
